AIR LEAKAGE AND RATTLING NOISE DETECTION IN LOUDSPEAKER HOUSINGS

Jannis Verhoeven¹, Tim Rzepczyk¹, Ole Blumenreich² and Lukas Görg¹

¹TU Berlin

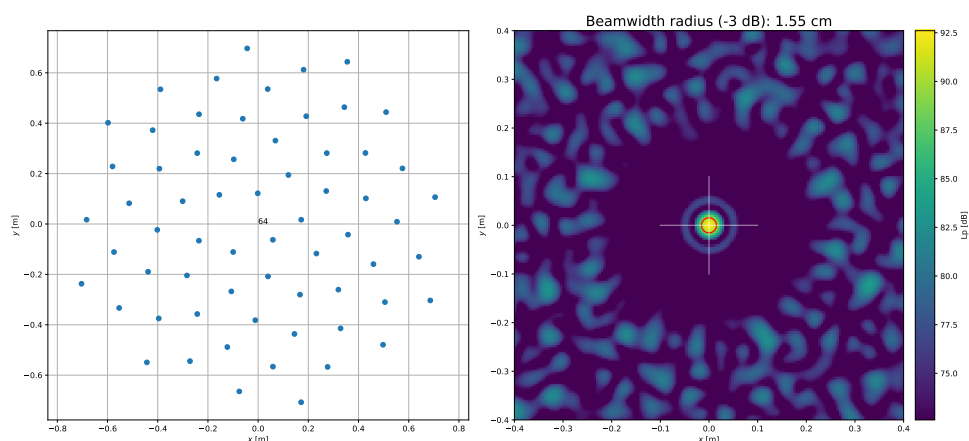
Figure 1: Array Geometry (left) and PSF for a source at distance 0.8 m at 8 kHz

A 64-channel microphone array (GRAS 40PM miniature microphones) was arranged in a Vogel spiral geometry [3] with an aperture of 1.5 m. The Vogel spiral provides uniform spatial sampling and effective sidelobe suppression compared to regular grid arrangements. The point spread function (PSF) has a -3 dB main-lobe diameter of 3.1 cm at 8 kHz for a source 0.8 m from the array, which was deemed sufficient spatial resolution for resolving individual defect features on the enclosure surface (Fig. 1).

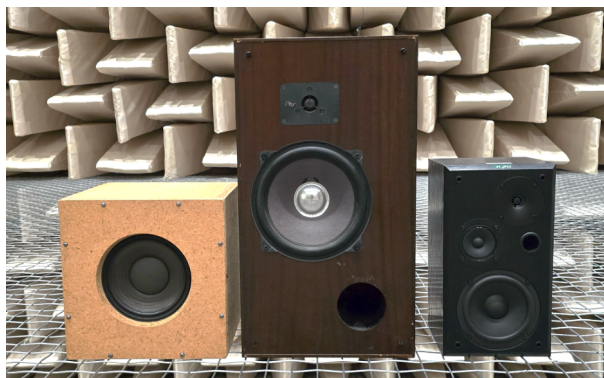
Figure 2: DUTs: DIY Woofer (left), ATR Hifi Speaker (center), Eltax Century 150 (right)

To evaluate the proposed approach, three different passive loudspeakers were investigated (Fig. 2). Their properties are described in Table 1. The DIY Woofer unit showed four bore holes of approximately 4 mm diameter on one side, arranged in a square pattern with a side length of 8 cm (Fig. 4(a)). The ATR Hifi speaker was modified by removing the lower left screw from the tweeter unit (Fig. 4(b)). For the Eltax Century 150 speaker, all four screws on the front plate of the tweeter were loosened, resulting in a rattling of the whole plate (Fig. 4(c)).

DUT	$H \times W \times D$ [m]	Design	Defect
DIY Woofer	$0.33 \times 0.33 \times 0.33$	single way, closed-box	four bore holes, 4 mm diameter
ATR Hifi	$0.64 \times 0.35 \times 0.31$	two way, vented	removed screw from tweeter
Eltax Century 150	$0.44 \times 0.22 \times 0.20$	three way, vented	loosened tweeter front plate

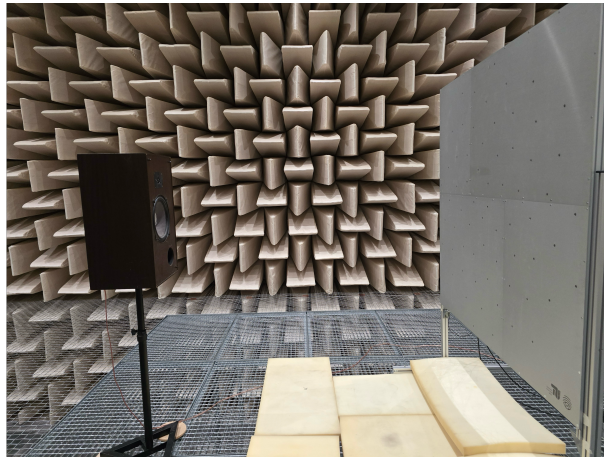
Figure 3: Measurement Setup at Anechoic Chamber, TU Berlin

The array was placed facing the front side of the loudspeaker at a distance of approximately 0.8 m (Fig. 3), with the geometric center of the loudspeaker aligned with the array center. The loudspeaker was excited with a low-frequency sinusoidal signal (40 Hz or 50 Hz, depending on the loudspeaker capabilities) to induce large diaphragm displacement, which maximizes the pressure inside the cabinet and thereby the acoustic emission of any air leaks. The speaker was manually rotated by 90° and the measurement was repeated for the three remaining sides (right, back, left). The up- and downward-facing sides were omitted. The measurements took place in the anechoic chamber of TU Berlin.

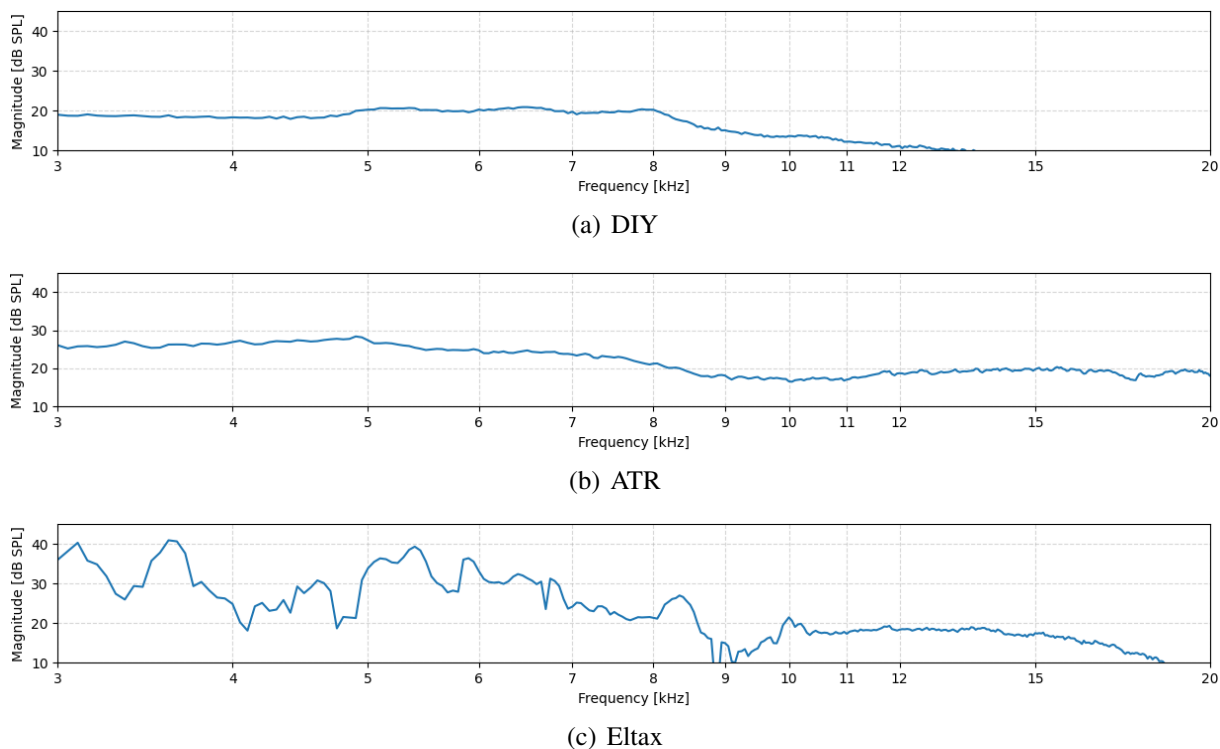
Restricting the spectrum to the spatial region of the localized defect yields the signatures shown in Fig. 5. The DIY and ATR spectra are broadband and qualitatively similar: an approximately flat magnitude up to 7 kHz, followed by a gradual roll-off. The Eltax spectrum, in contrast, exhibits sharp peaks and substantially higher level variability across the analyzed band.

Figure 5: Region-of-interest spectra at the localized defect for the (a) DIY, (b) ATR, and (c) Eltax enclosures.

Second, the spectrum recovered at the localized region distinguishes leakage from rattle and thereby supports root-cause discrimination from a single measurement. The DIY and ATR spectra are broadband and roughly flat up to 7 kHz, which is the shape one expects from turbulent flow through a small aperture and supports interpreting both defects as leakage-dominated. The Eltax spectrum, in contrast, exhibits sharp peaks and substantially higher level variability across the analyzed band, consistent with intermittent mechanical contact between the tweeter plate and the cabinet rather than with continuous airflow. The contrast between these spectral signatures is sufficiently clear that the failure mode could in principle be classified from the spectrum alone, without prior knowledge of the defect type.

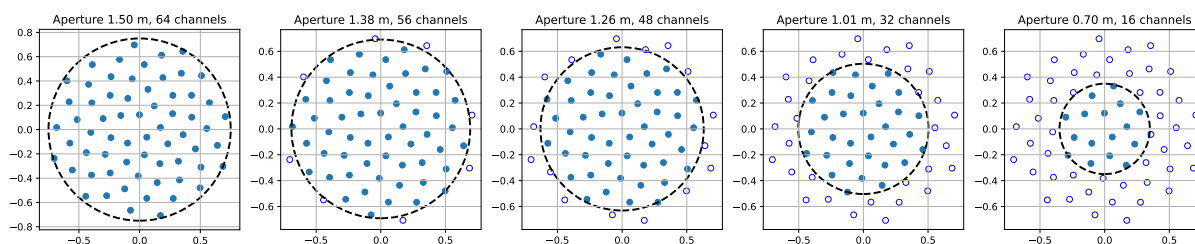
Figure 6: Microphone subset configurations used in the reduction study. Active channels are filled, deactivated channels are open.

The previous results were obtained with the full 64-channel, 1.5 m-aperture array. For practical deployment, both the channel count and the physical dimensions should be as small as the task allows. We therefore evaluate localization performance under progressive deactivation of outer microphones, which reduces both channel count and aperture. Figure 6 shows the five tested subsets, ranging from 64 channels at 1.5 m aperture to 16 channels at 0.7 m aperture.

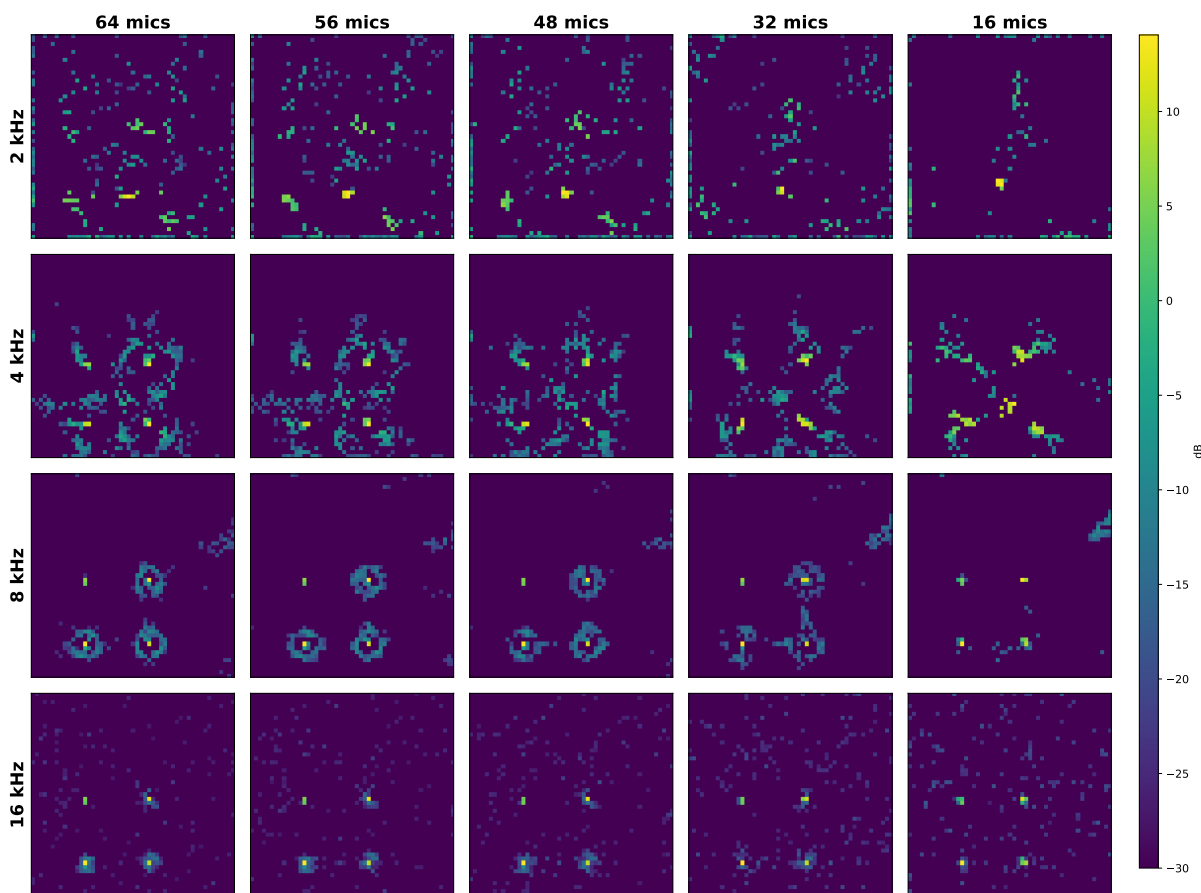
Figure 7 reports Clean-SC maps of the DIY enclosure across the five subsets and four analysis frequencies. Three observations can be made: At 2 kHz, no configuration resolves the

Figure 7: Clean-SC maps of the DIY enclosure for five subset configurations (columns) at four analysis frequencies (rows).

bore holes: the maps are dominated by sidelobes and incoherent structure across all channel counts, reflecting the fundamental aperture limit. At 4 kHz, the four sources begin to emerge for the larger configurations but remain corrupted by sidelobes. The 64-channel result is only marginally cleaner than the 16-channel result. At and above 8 kHz, all five configurations, including the smallest 16-channel, 0.7 m subset, recover the four bore holes with comparable clarity. The 64-channel array offers little advantage in this setting.

Third, this performance is largely maintained when the channel count is reduced from 64 to 16 and the aperture from 1.5 m to approximately 0.7 m, provided a deconvolution beamformer is used. For defect localization at frequencies above 8 kHz, a 16-channel array of approximately 0.7 m aperture is therefore sufficient — a quarter of the channels and roughly half the aperture of the reference configuration. The corresponding reduction in hardware cost, physical dimensions, and integration complexity suggests that the entry barrier for array-based inspection in an end-of-line setting can be quite low.
